TORBAY CATCHMENT RESTORATION PLAN

WATERSHED Torbay

July 2006

Department of Water 2006, *Torbay Catchment Restoration Plan*, Department of Water

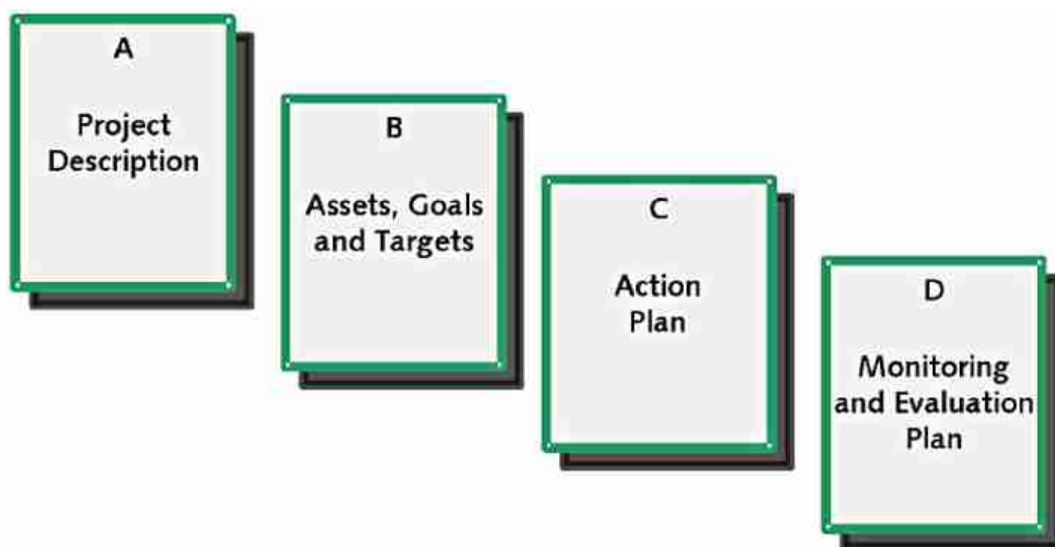
Figure A1 – Sections of the Torbay Catchment Restoration Plan

The Torbay Catchment Restoration Plan consists of four sections (Figure A1). The plan incorporates all relevant information leading to the actions to be taken. It also provides a framework for monitoring and evaluation linked through adaptive management to the implementation processes. The plan outlines resource and capacity requirements for efficient implementation of the actions and effective communication of the results.
